CASTLE ROCK MONITORING

July 30, 2021

prepared by Emu Systems
for Colorado Earth
COE001

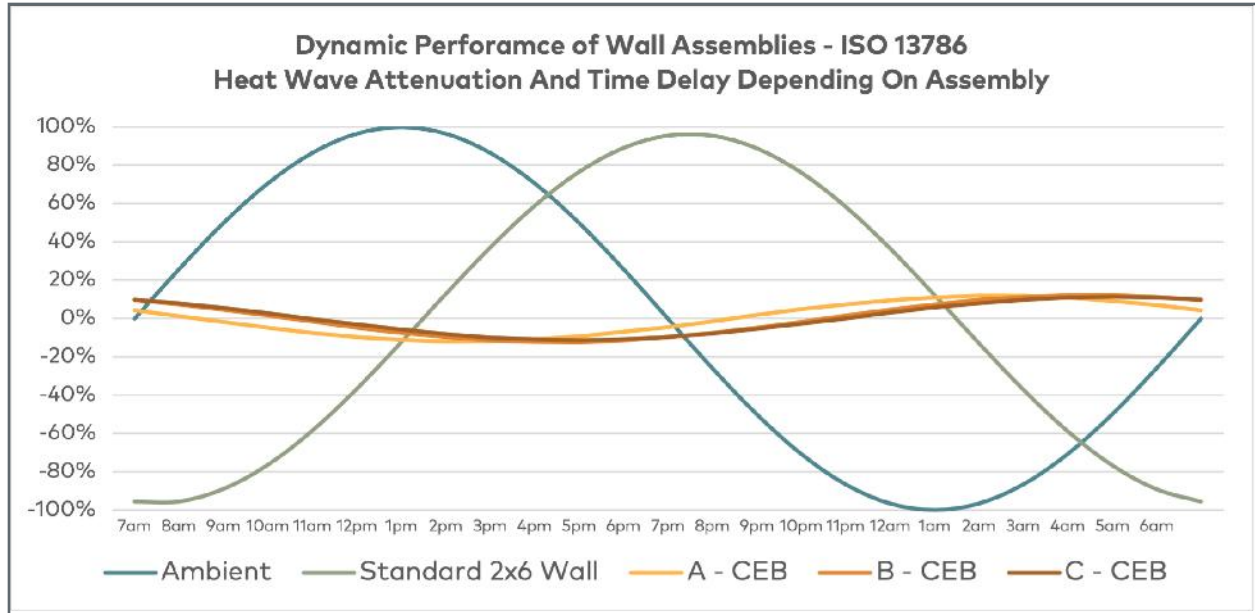
Image 03: Results of thermal attenuation and delay of the assemblies considered, as modeled per ISO 13786 with Mold Simulator. For further details, see Appendix A.

The dynamic performance of the CEB assemblies was modeled in compliance with ISO 13786 [9], using Mold Simulator v5 [5]. The results are listed in Table 04, and illustrated in Image 03. For further details of the results, see Appendix A.

The data collected in July 2019 shows a behavior of the CEB walls very close to the dynamic performance (i.e. thermal attenuation and time delay) modeled according to ISO 13786. Ref. Image 03 above.

The dynamic performance of CEB wall assemblies compared to a regular 2x6 wall is supported by the data collected. The ISO 13786 modeling results in terms of attenuation and time delay are comparable to the data collected from the Castle Rock project (images 03 and 19 respectively).

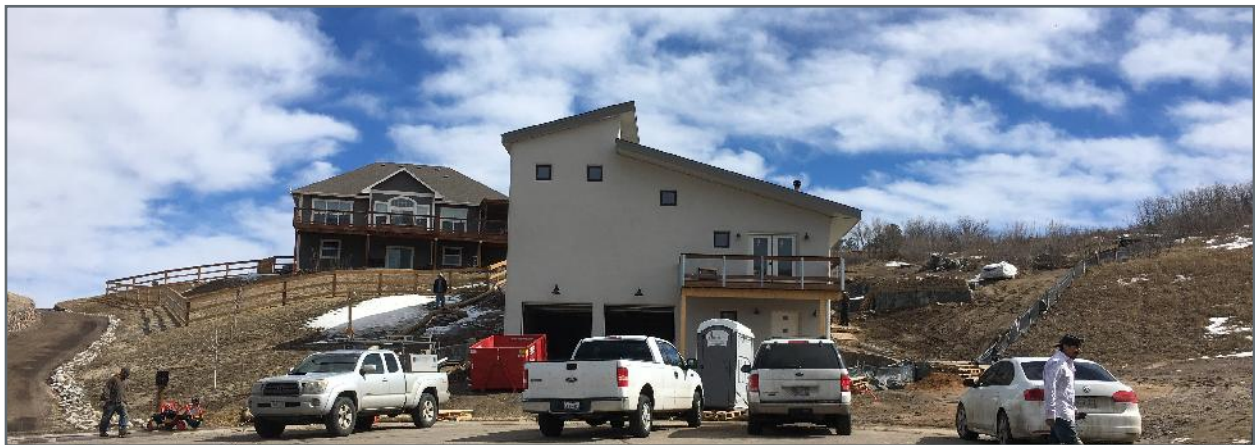
Image 04: View of the West elevation of the building.

The monitored building is a single family house built in Castle Rock, Colorado. The building constitutes of two stories plus a loft space, with the main living space located at the second floor.

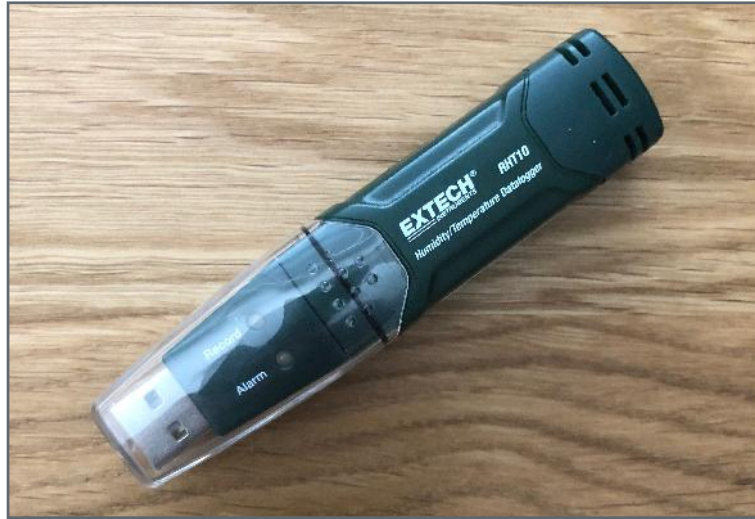
Image 10: Extech RHT10 data loggers used to record conditions in the Great Room as well as ambient conditions outside the building.

2. Data loggers used to record conditions in the Great Room, as well as ambient conditions outside the building.

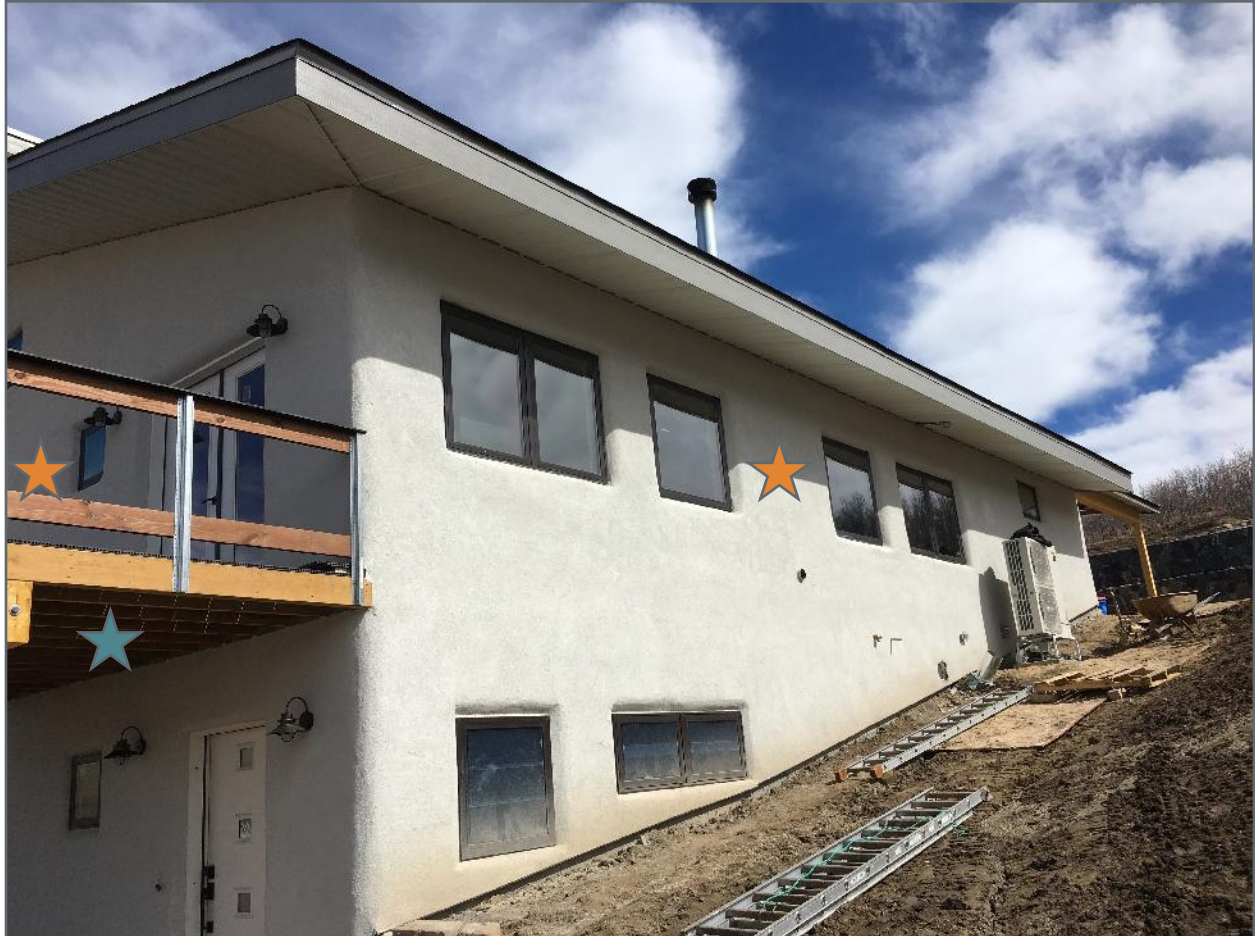
Image 12: View of the South and West walls of the building (respectively: right and left). The stars indicate the approximate locations of the embedded sensors (orange), and the ambient data logger under the deck (blue).

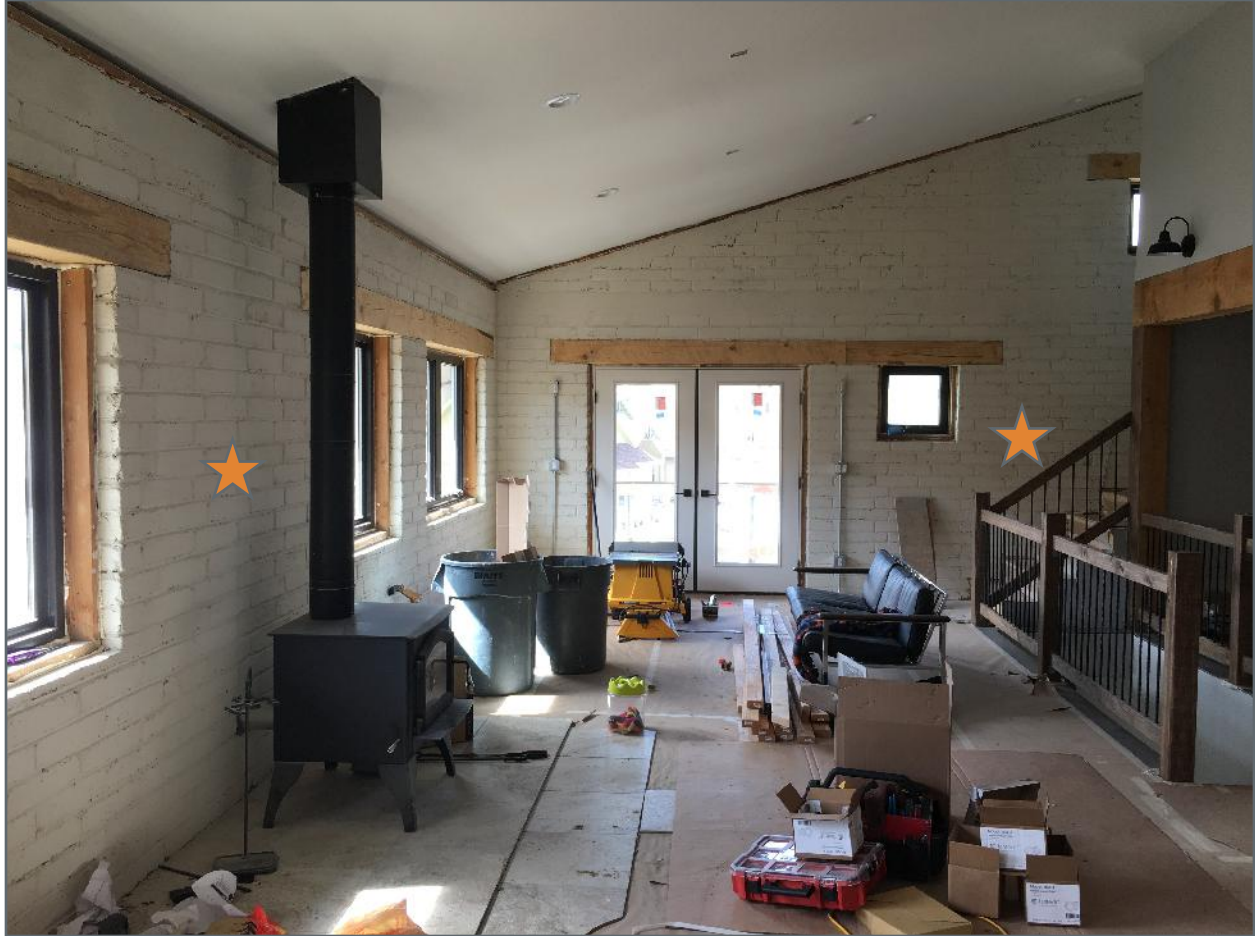
Image 13: View of the Great Room while the building was about to be completed. The two stars show the approximate location of the sensors embedded in the South wall (left), and in the West wall (right).

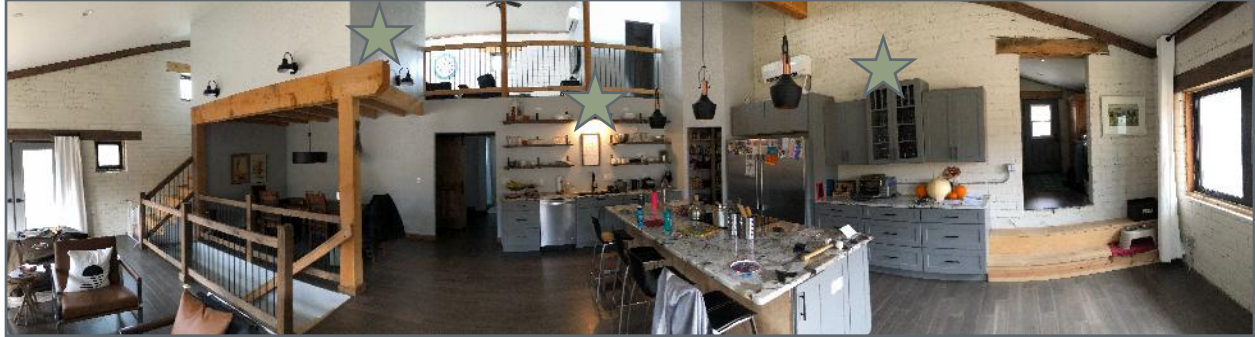
Image 14: Panoramic view of the Great Room looking North towards the kitchen, approximately from the location of the wood fire stove. The green stars indicate the approximate locations of the data loggers used to record the conditions inside the Great Room.

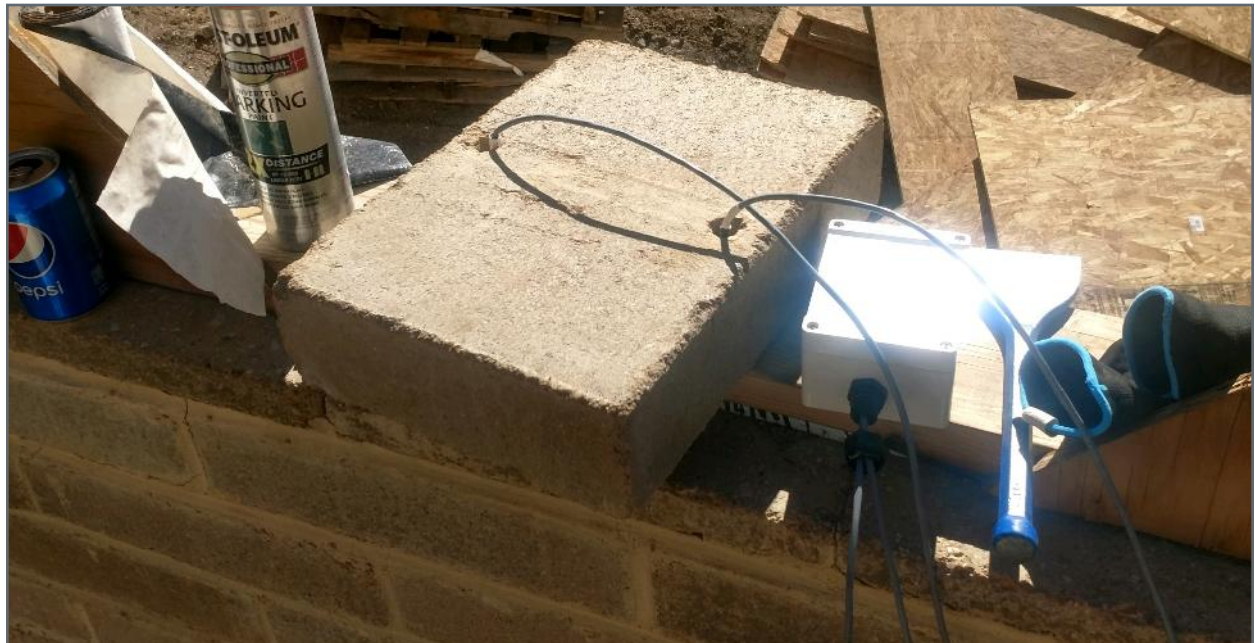
Image 15: A CEB block being prepared with the two embedded sensors.

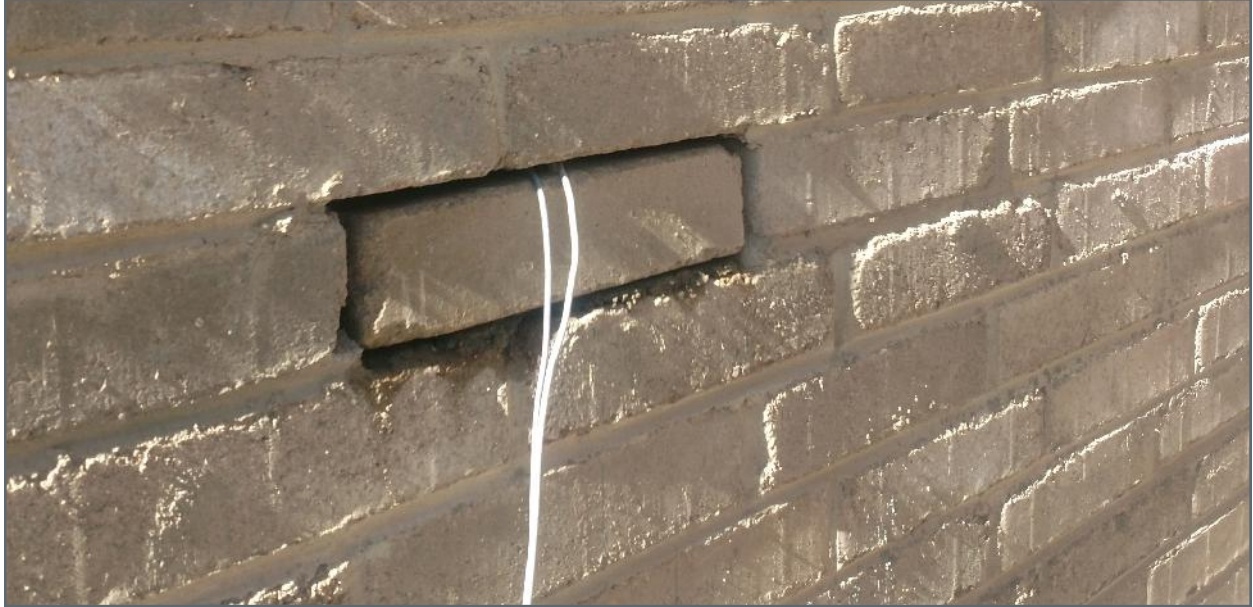
Image16: A CEB block equipped with the embedded sensors, as installed in a CEB wall in the Castle Rock project.

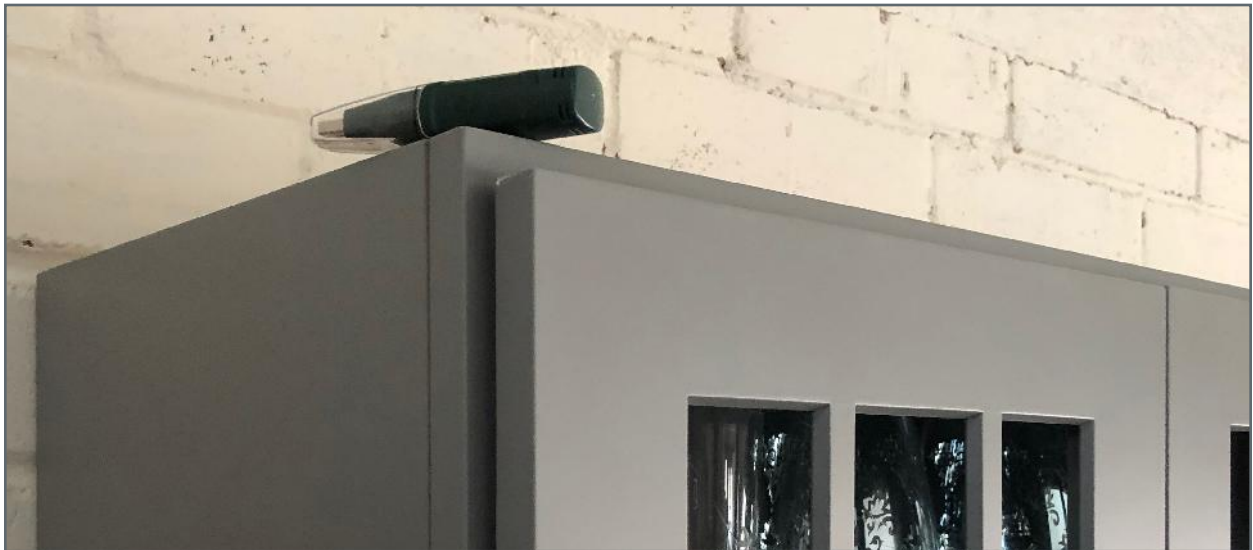
Image17: One of the data loggers installed in the Great Room.
